RESEARCH MEMORANDUM

VIBRATION OF TURBINE BLADES IN A
TURBOJET ENGINE DURING OPERATION

By W. C. Morgan, R. H. Kemp
and S. S. Manson

NATIONAL ADVISORY COMMITTEE FOR AERONAUTICS

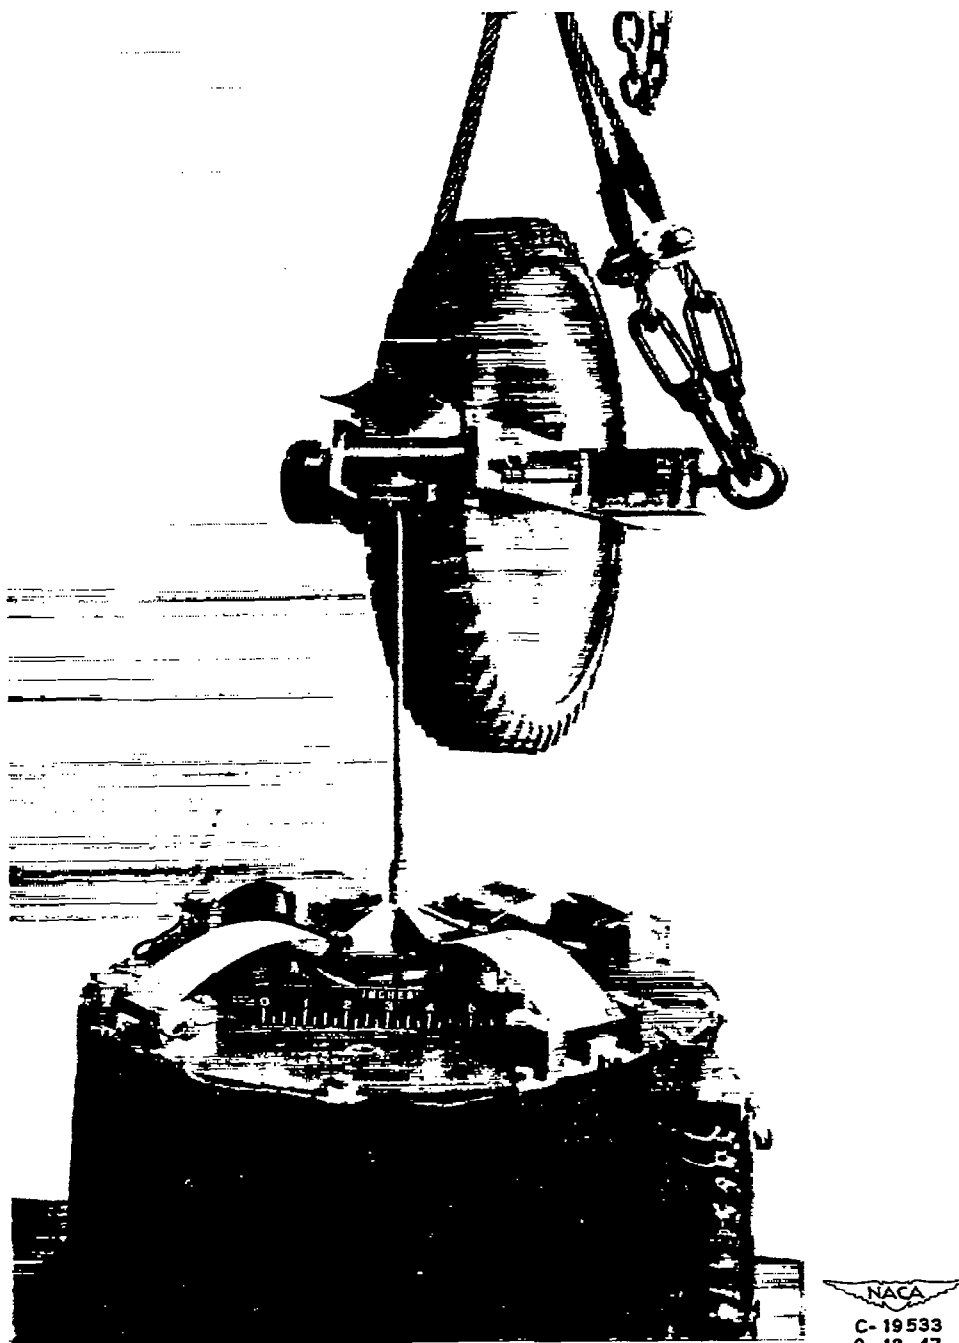
Figure 1. - Excitation equipment used in determination of nodes in turbine blade during various natural vibration modes.

Modes of vibration. - The nodal patterns in the various natural modes of vibration were determined by preliminary bench tests on a blade similar to those used in the dynamic investigations. In producing these patterns, the blade was inserted in a turbine disk with a tight fit in order to approximate the rigidity in a completely bladed wheel; vibration was excited by a speaker-type unit of variable frequency. In order to avoid mechanical damping or restraint of the blade, the excitation force was transmitted through a steel rod attached to a stub blade adjacent to the test blade in

the turbine disk. The turbine disk was suspended in a sling above the exciter (fig. 1).

The excitation frequency was varied until resonance was observed by means of a crystal pickup. Location of the nodes was accomplished by moving the needle point of the pickup device along the lines of a grid drawn on the concave face of the blade until an oscilloscope signal indicated a minimum amplitude. Location of a sufficient number of such points was recorded to establish the location of the nodes for each of the resonant frequencies.

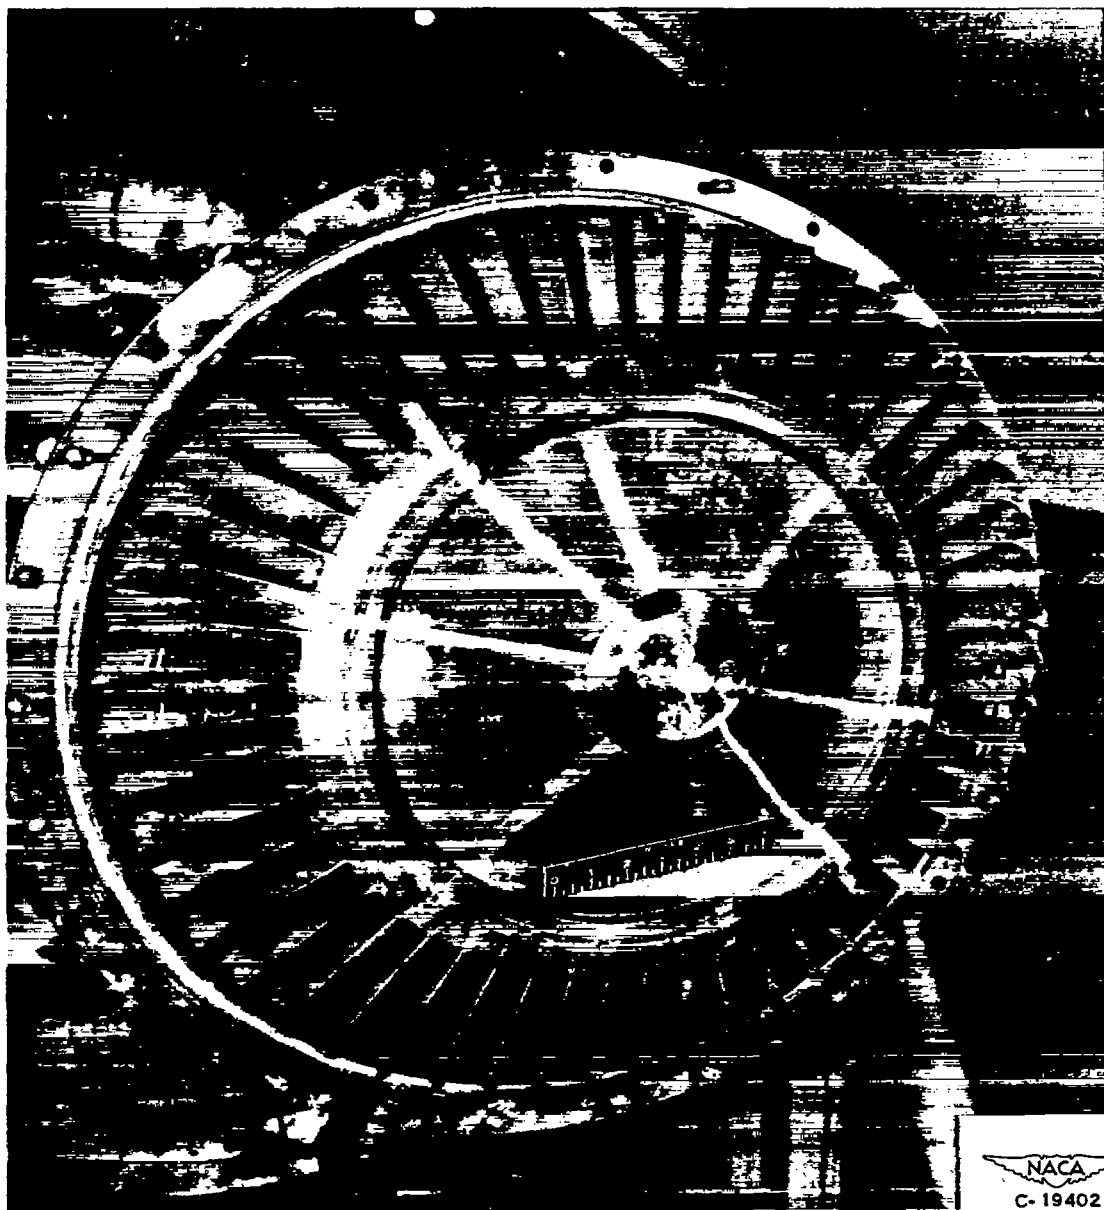
Figure 2. - Installation of high-temperature strain gages on turbine blades showing location of blades and lead wires.

The instrumented blades were inserted in the turbine wheel, the lead wires cemented to the rear face of the turbine rotor, and the lead-wire cement baked by radiation from infrared lamps. The lead wires were connected to a circular terminal block at the center of the turbine wheel (fig. 2).

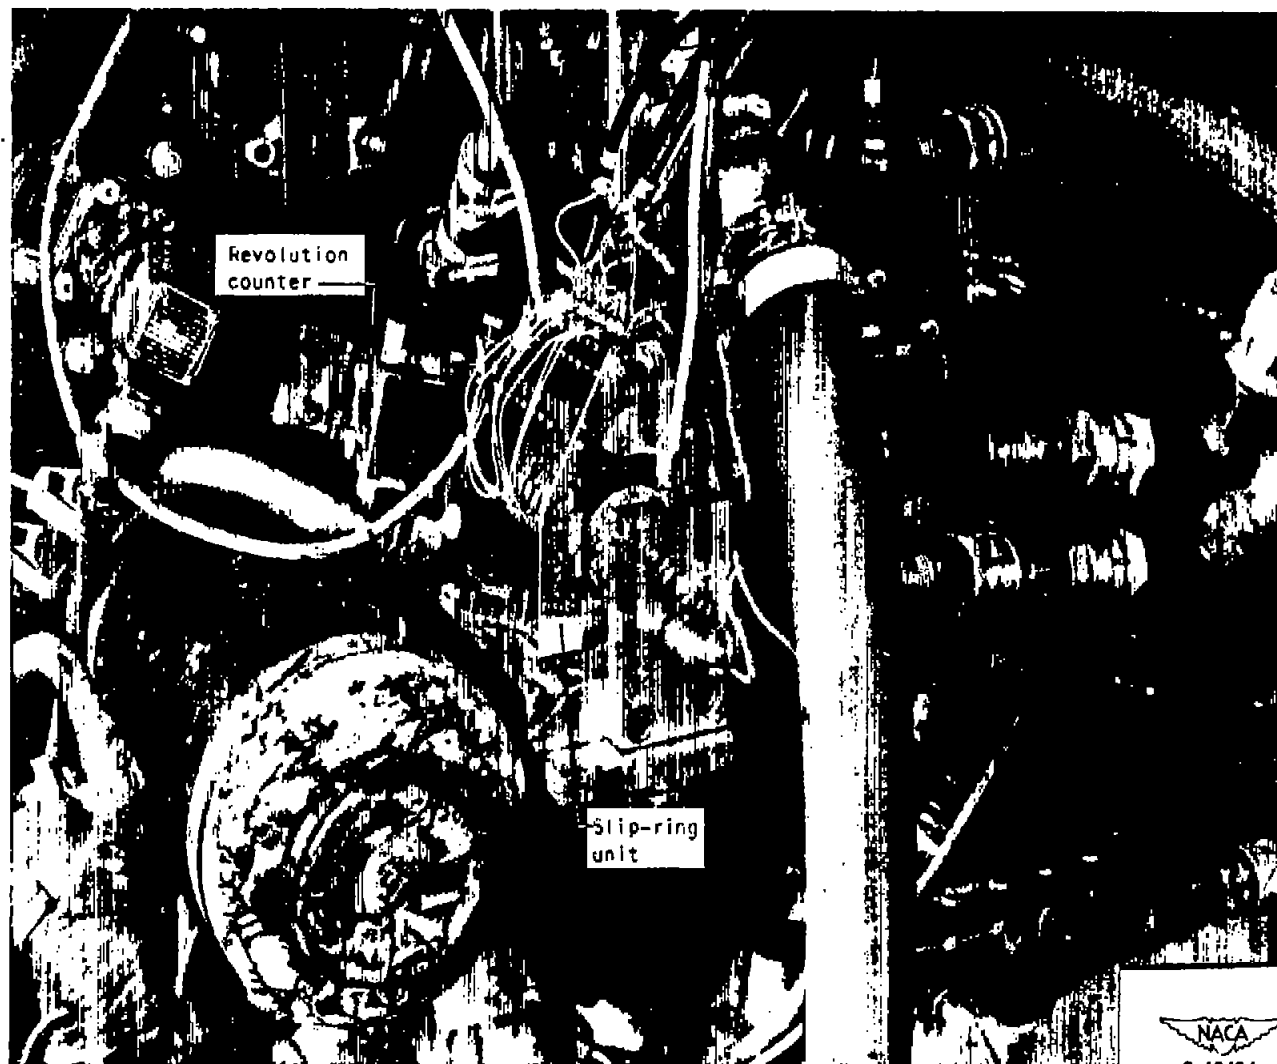
Figure 3. - Slip-ring unit for transmittal of turbine-blade strain-gage signal to stationary instrumentation.

Several components of the engine were modified in order to provide passage of the lead wires from the strain gages to the slip rings necessary for transmittal of strain-gage signals to stationary observation and recording instrumentation. The principal modifications consisted of axial passages bored through the turbine wheel, the compressor, and the shafts connecting these components. A hollow auxiliary shaft, connected to the compressor, extended through the accessory housing on the forward end of the turbojet engine to provide a connection to the slip-ring unit on the accessory housing (fig. 3). A magnetic revolution counter, which

also appears in figure 3, was used in order to provide a more accurate determination of turbine speed than could be obtained with the standard turbojet tachometer.

The slip-ring unit was of the cylindrical type with all rings of the same diameter. The strain-gage signals were transmitted through brushes mounted at an angle to the radii in the plane of each slip ring. The slip rings were monel metal and the brushes were silver graphite.

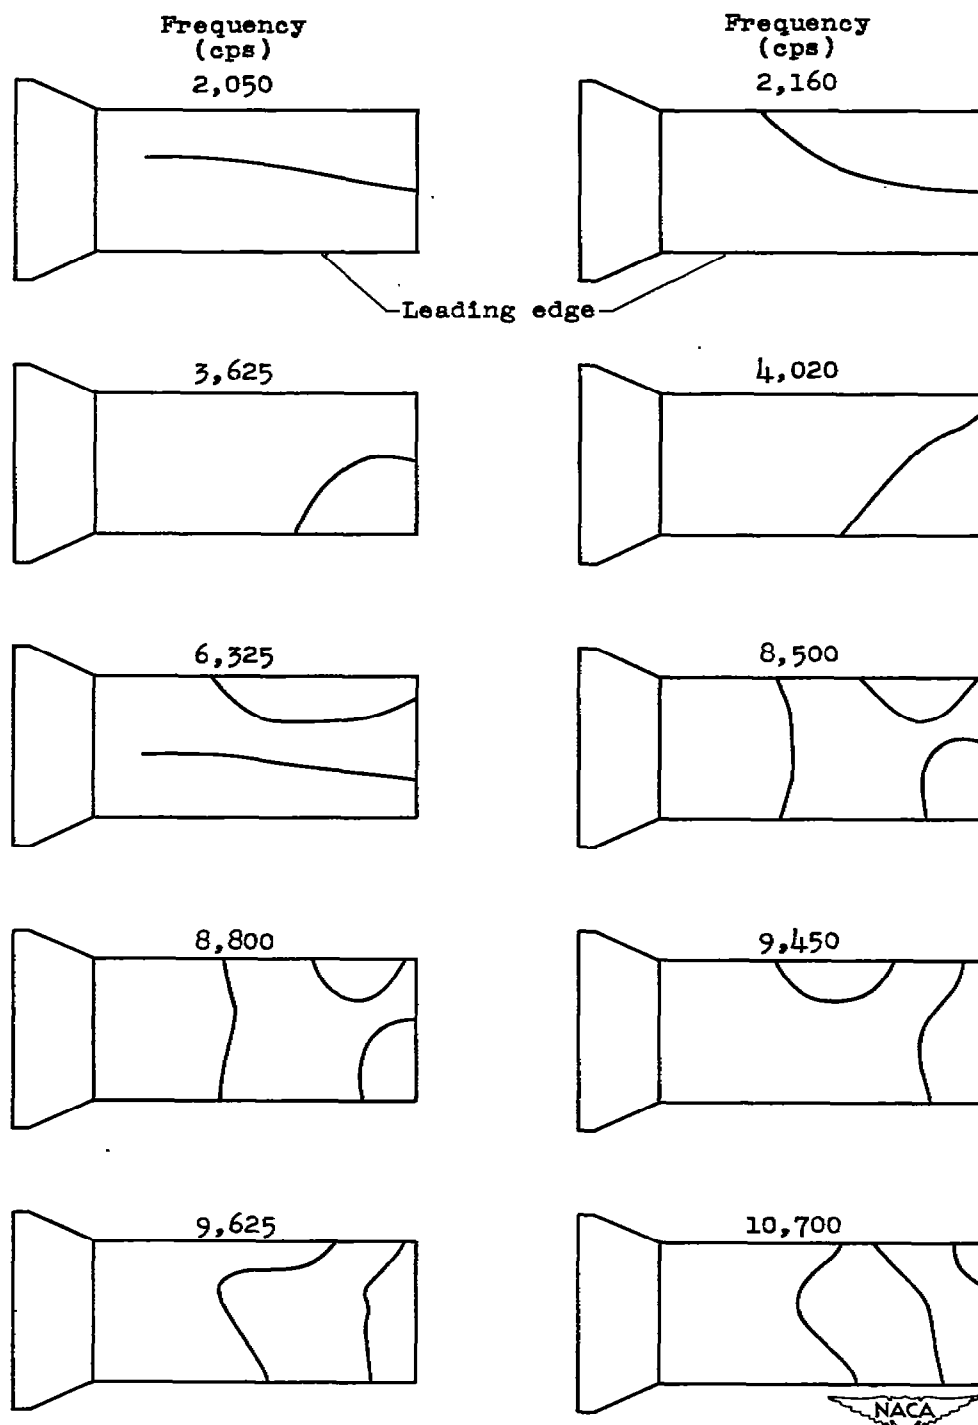
Figure 4. - Nodal patterns of 10 vibration modes determined.
Fundamental frequency, 1270 cycles per second.

Nodal patterns were obtained on a blade of the same type as those instrumented with strain gages to determine the approximate frequencies of resonant vibration of the blades. The nodal patterns of 10 vibration modes that were excited by means of the

speaker-type exciter are shown in figure 4. The fundamental bending mode, not shown in the figure, occurred at a frequency of 1270 cycles per second. A point of interest was the similarity of the nodal pattern at 8500 cycles per second to that at 8800 cycles per second, a similarity apparently caused by the simultaneous occurrence of two modes mechanically coupled. Although similarity often exists among vibration nodal patterns at very high frequencies, the node patterns at 9450, 9625, and 10,700 cycles per second are dissimilar.

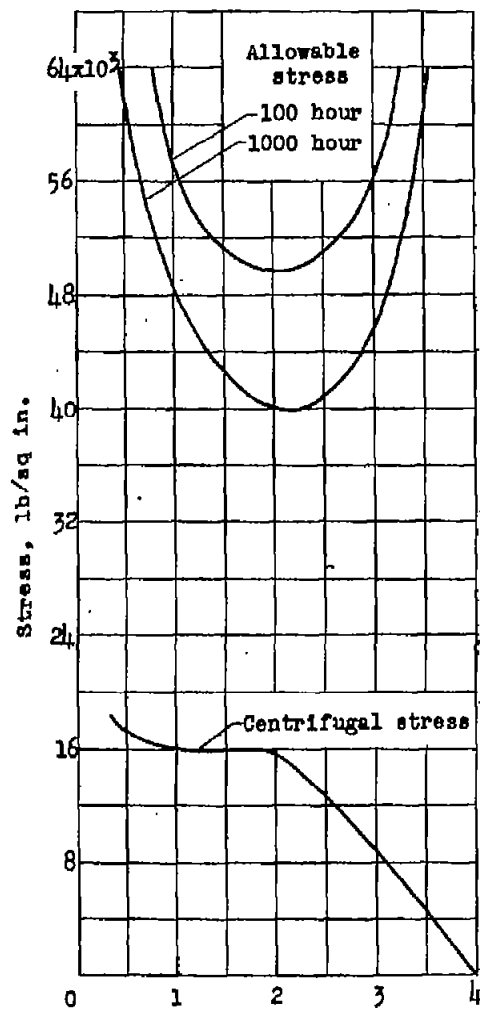
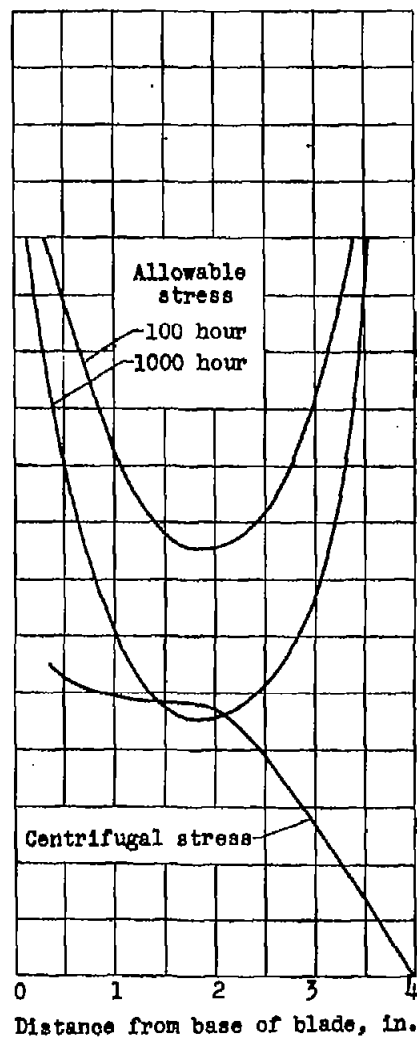
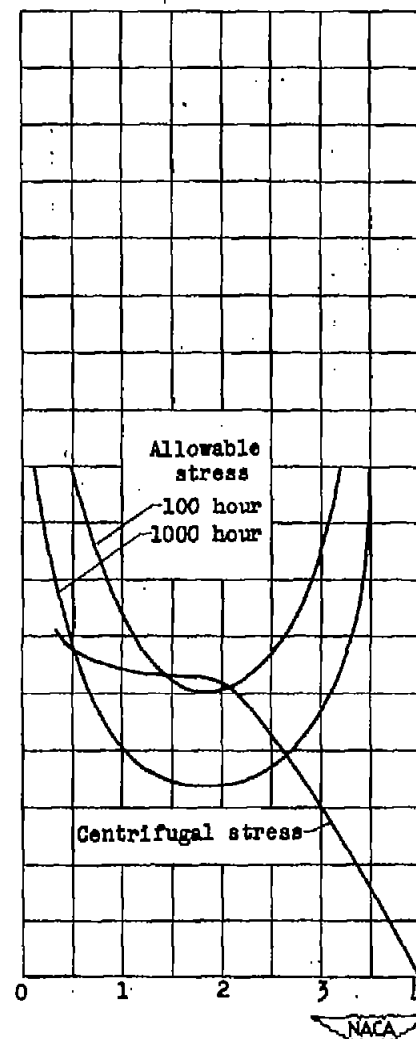
(a) Turbine speed, 10,000 rpm.

(b) Turbine speed, 11,000 rpm.

(c) Turbine speed, 11,500 rpm.

Figure 5. - Comparison between calculated centrifugal stress and allowable stress as computed from stress-rupture data for turbine blade at several turbine speeds.

The centrifugal stresses in the blade at different speeds of operation were first computed in order to assist in the interpretation of the significance of the vibratory stresses. The results are shown in figure 5. The centrifugal stresses at various locations along the length of the blade are shown for turbine speeds of 10,000, 11,000, and 11,500 rpm. Bending stresses due to gas loading are not included in these calculations because the stress values are to be used only qualitatively. Also plotted in this figure are the allowable stress values at each location along the blade, based upon the temperature distribution in the blade (reference 2) and the stress-rupture values for Vitallium at each temperature for durations of 100 and 1000 hours. For speeds below 11,000 rpm, a margin of safety exists between the operating centrifugal stress and the stress-rupture values. At or above 11,000 rpm, little margin of safety exists at any location in the blade and even small vibratory stresses may be sufficient to precipitate fatigue failure.

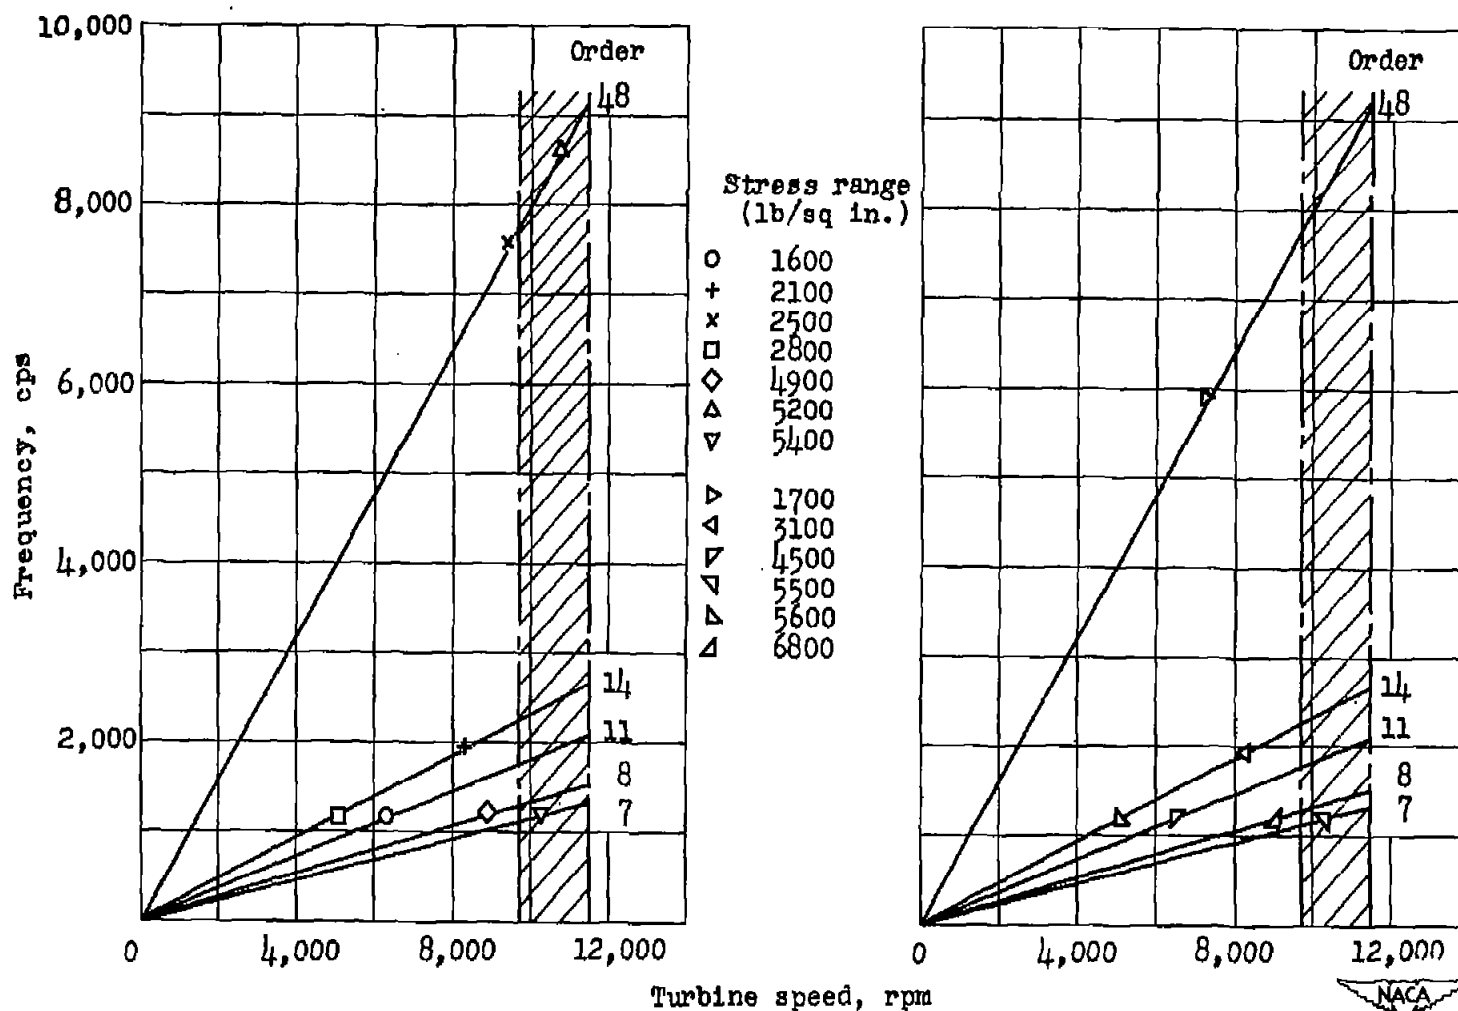
Figure 6. - Resonance spectra showing occurrence of vibration. Shaded area indicates cruising range.

An analysis of the vibration data obtained on two of the blades is shown in figure 6. These blades were standard turbine blades mounted diametrically opposite. Each of the data points represents an engine speed at which vibration was observed and the frequency of the blade vibration. Also shown are a series of solid lines labeled order. Each of these lines represents the locus of points at which the frequency in cycles per second is a definite multiple of the frequency of turbine rotation in revolutions per minute. Such lines therefore define, at any engine speed, the frequency of any exciting force that occurs at a definite multiple of engine speed. For example, because there are 14 combustion chambers in this engine, an excitation due to the velocity profile of these combustion chambers would occur 14 times for every engine revolution. The frequency of combustion-chamber excitation at any

engine speed is therefore represented by the line for fourteenth order. A correlation between the observed points of blade vibration and the lines of multiple order is useful in ascertaining the sources of vibration excitation.

In addition to those points of sustained vibration shown in figure 6, several transient vibrations in the first bending mode at 1200 cycles per second were recorded near full-speed operation of the engine. These vibrations were recorded on the oscillograph film but were not visually identified on the oscilloscope screen. The duration of any of these vibrations was short, approximately $1/50$ second; the cause of the vibrations was not ascertained. These vibrations could not be neglected, however, because of their occurrence at the speeds producing the greatest severity of temperature and centrifugal-stress conditions. Another point of interest not demonstrated in figure 6 was the absence of significant vibrations during a run in which the engine was accelerated from 4000 to 11,500 rpm within a period of 15 seconds while the oscillograph was continuously operated. Apparently sufficient damping existed to prevent the building up of vibration during rapid acceleration.

Inspection of figure 6 shows that the important orders of excitation are 7, 8, 11, 14, and 48. Excitations of the forty-eighth order are to be ascribed to the 48 nozzle blades in the turbine. In blade A, this source of excitation produced a stress range of 5200 pounds per square inch at a speed in the cruising range of the engine, where the temperatures are high and the margin of safety is low. The frequency of this vibration was 8600 cycles per second. Blade B was also excited by the forty-eighth order but at a different frequency, probably because of differences in the blade mounting. This vibration at a frequency of 5900 cycles per second did not occur within the cruising range.

The fourteenth-order excitation can be attributed to the 14 combustion chambers in the engine. This source produced first torsional vibrations at a frequency of 2000 cycles per second with a stress range of 2100 pounds per square inch in blade A and a stress range of 3100 pounds per square inch in blade B. Because the engine speed at which these vibrations occurred was below the cruising range of the engine, sustained vibrations due to this source are not likely and, moreover, they occur when the temperatures and the centrifugal stresses are relatively low so that greater vibrational stress is tolerable. The combustion chambers also produced fundamental bending vibrations at a frequency of 1170 cycles per second in both blades at a speed of approximately 5000 rpm but these vibrations are probably not of great importance because of the low speeds at which they occurred.

Vibrations due to eighth-order excitations may be of importance. Although these vibrations in the fundamental bending mode at 1200 cycles per second occur at a speed below the cruising range, their relative amplitude is high. In blade B, the highest vibratory stress range observed of 6800 pounds per square inch was excited by an eighth-order effect.

The seventh-order excitations, which are important, produced vibrations in the fundamental bending mode at a frequency of 1200 cycles per second. The stress range for both blades produced by this excitation was relatively high (about 5500 lb/sq in.) and occurred at a speed of about 10,300 rpm, which is within the cruising range of the engine and is accompanied by high blade temperatures and centrifugal stresses. Several possibilities exist as the source of this order of excitation. One of the more probable causes may be that inequalities of mass flow from the various combustion chambers produce numerous harmonics of engine speed and the lowest order that can excite blade vibrations at any speed within the operating range of the turbine is the seventh. Another possibility is that the response of the blade to excitation is nonlinear and would therefore tend to introduce a one-half-order excitation of the combustion chambers (reference 4).
